## **INTERLEAVED BISMALIMIDE COMPOSITES**

Eileen Armstrong-Carroll and Thomas M. Donnellan  
Air Vehicle and Crew Systems Technology Department (Code 6064)  
NAVAL AIR WARFARE CENTER  
AIRCRAFT DIVISION WARMINSTER  
P.O. BOX 5152  
Warminster, PA 18974-0591

**1 DECEMBER 1992**

**FINAL REPORT**  
Period Covering July 1989 to May 1991  
P.E. 62234N  
P.N. RS-34ASO

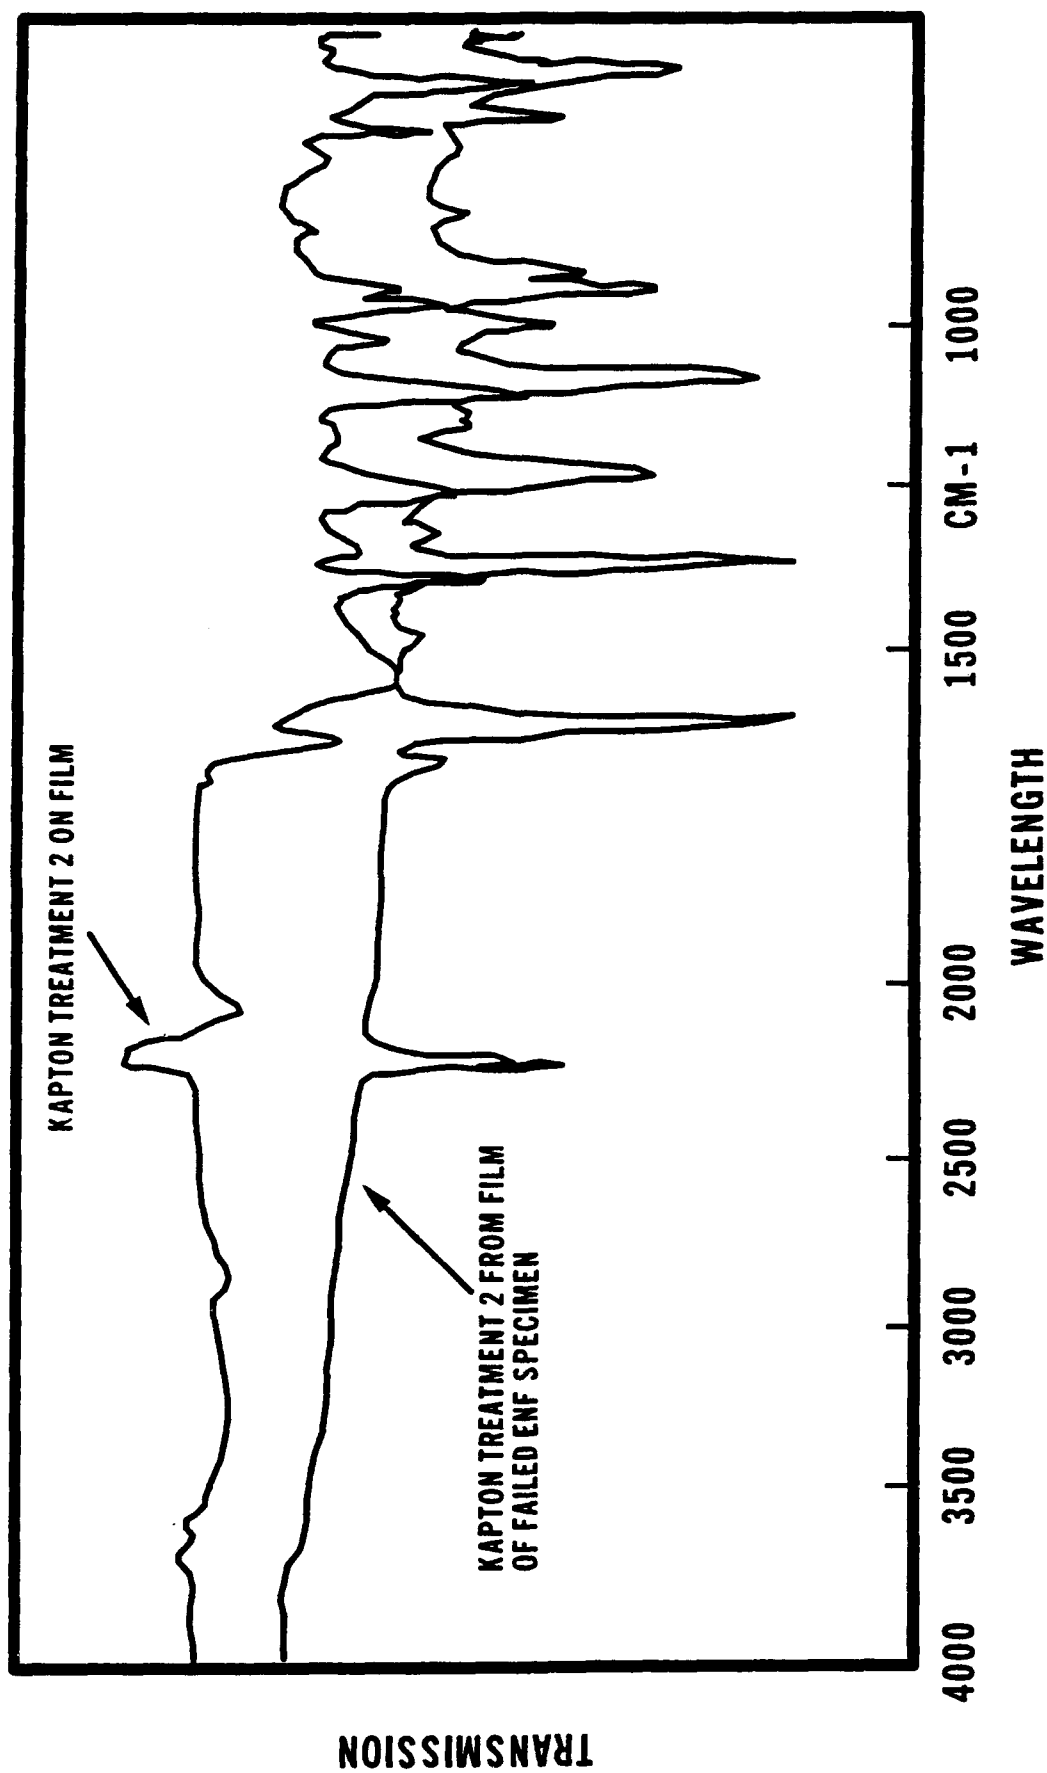
Figure 22. Spectrum Of An ENF Failure Surface Compared With Spectrum Of A Plasma Treated Film For Kapton Treatment Two. Allylamine Valleys Are Absent On The ENF Failed Film Surface.

The locus of failure for ENF samples is determined with FTIR. ATR spectra of the interleaf side of ENF failure samples were examined. Figures 22 and 23 show ATR spectra of plasma treated films and the film side of failed ENF specimens with kapton and teflon interleaf films. These spectra indicate that the transmission valleys due to allylamine do not appear on the fractured samples. With both film materials failure occurs at the film-grafted polymer interface. These results demonstrate the importance of film adhesion in the fracture process with interleaved composites.

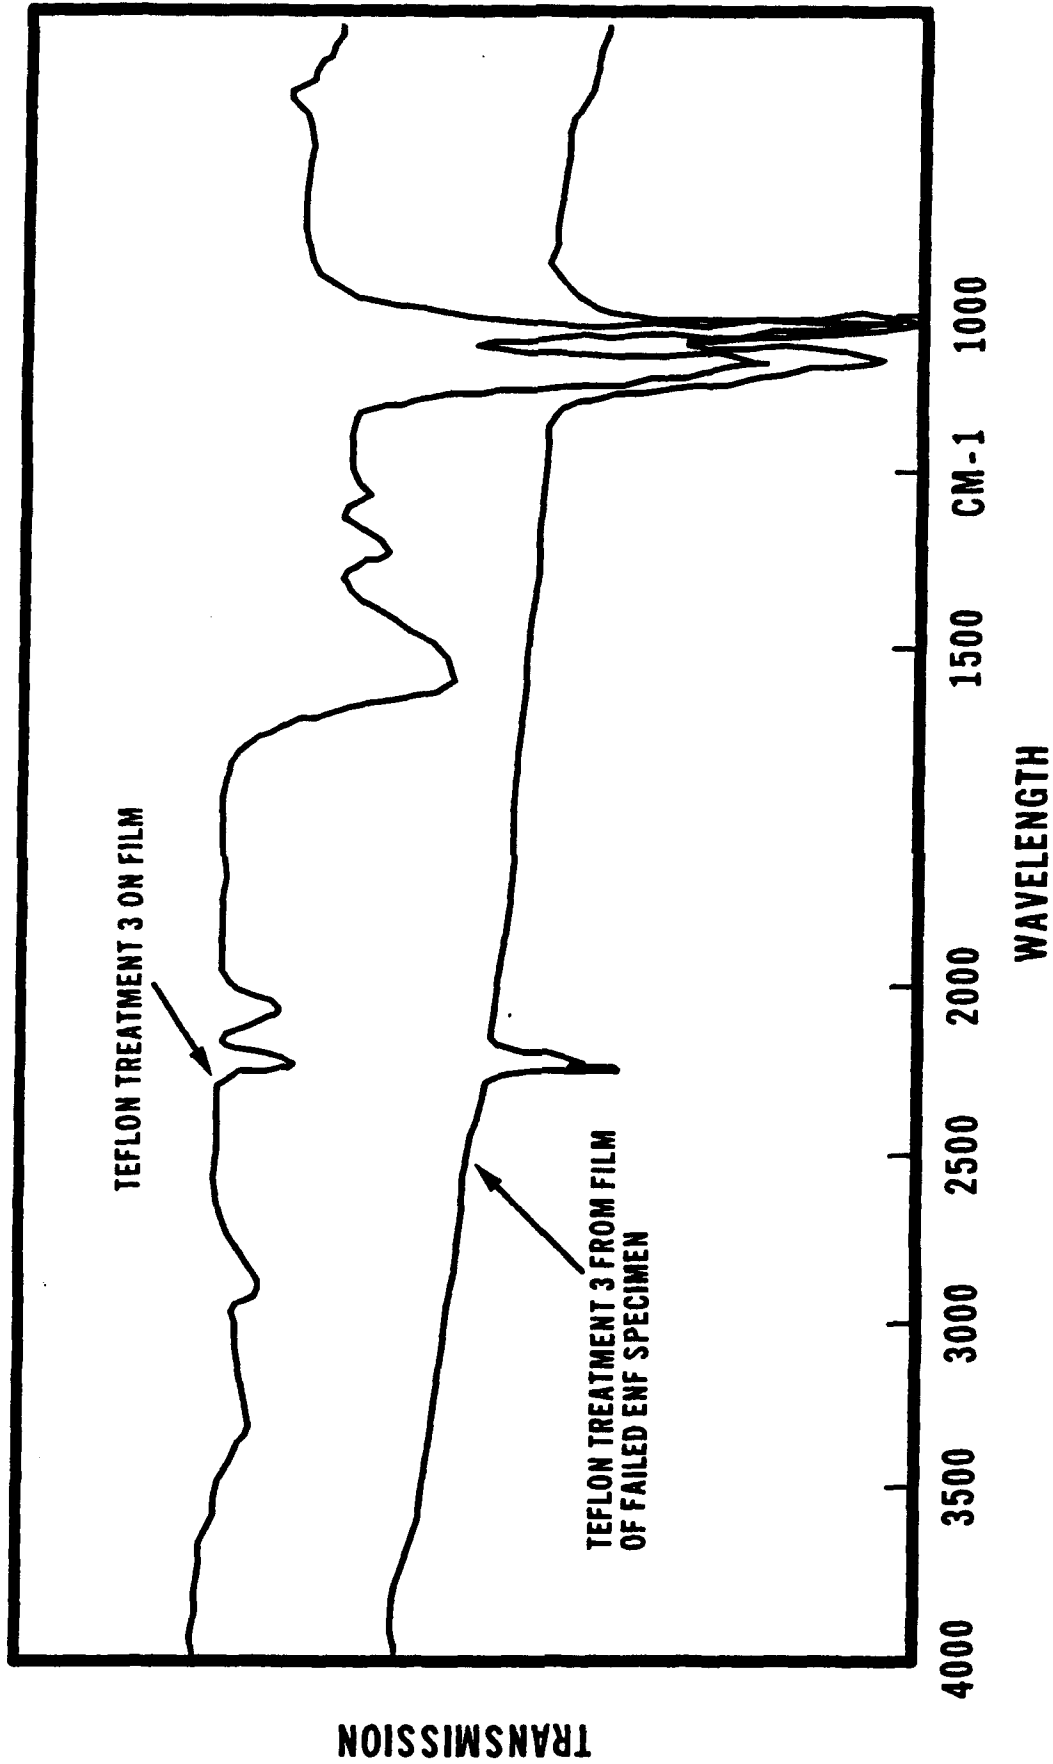
Figure 23. Spectrum Of ENF Failure Surface Compared With Spectrum Of Plasma Treated Film For Teflon Treatment Three.  
Allylamine Valleys Are Absent On The ENF Failed Film Surface.

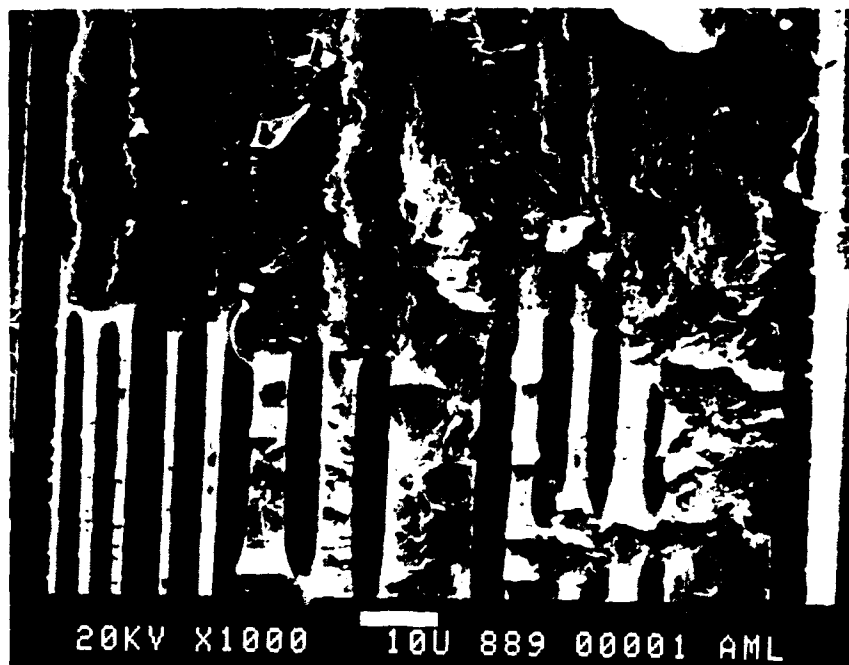
Figure 24. Cycom 3100/IM6 Composite Failed Through ENF Testing.  
Fracture Energy Absorbed Through Resin Fracture.

The ENF failure surfaces are also characterized with SEM. Figure 24 shows the ENF failure surface of a composite without an interleaf. With this material crack propagation energy is absorbed via resin fracture and fiber bridging. The  $G_{IIC}$  value of this composite is comparable to that of composites interleaved with untreated kapton. Figure 25 shows the failure surface of a composite interleaved with untreated kapton. With this material crack propagation energy is absorbed via film tearing. The fracture surface of plasma treated kapton interleaved composites (Figure 26) contains fewer sites of film tearing. However at these sites film deformation is more extensive. A limited number of hackles are evident on the interleaf surface. Thus even the addition of a brittle film as an interleaf material markedly increases the amount of crack propagation energy absorbed.

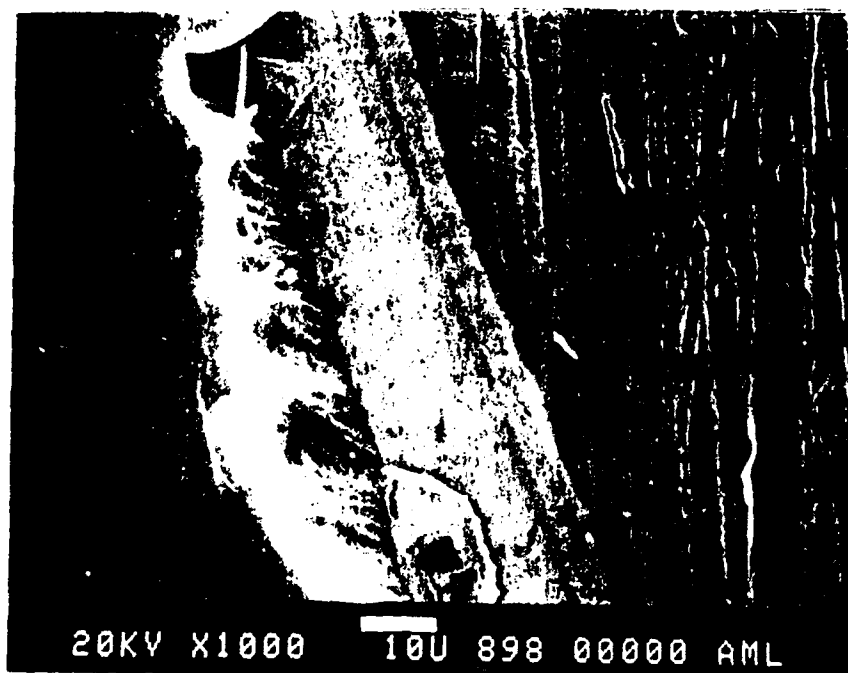
Figure 25. Cycom 3100/IM6 Composite, Interleaved With Kapton Failed Through ENF Testing.  
Additional Fracture Energy Absorbed Through Film Tearing.

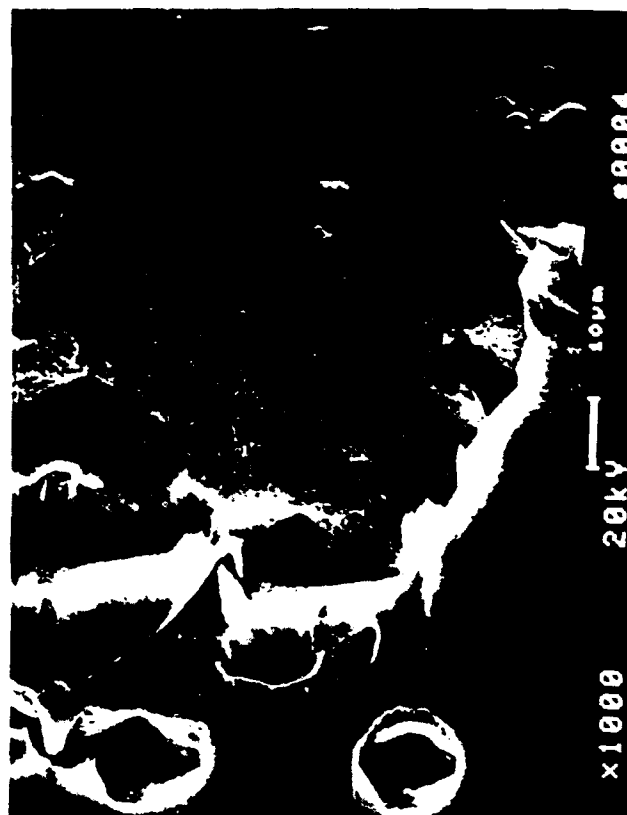
Figure 26. Cycom 3100/IM6 Composite, Interleaved With Kapton Treatment Two, Failed Through ENF Testing. More Deformation Is Evident At Film Tearing Sites. Some Hackles Are Evident.

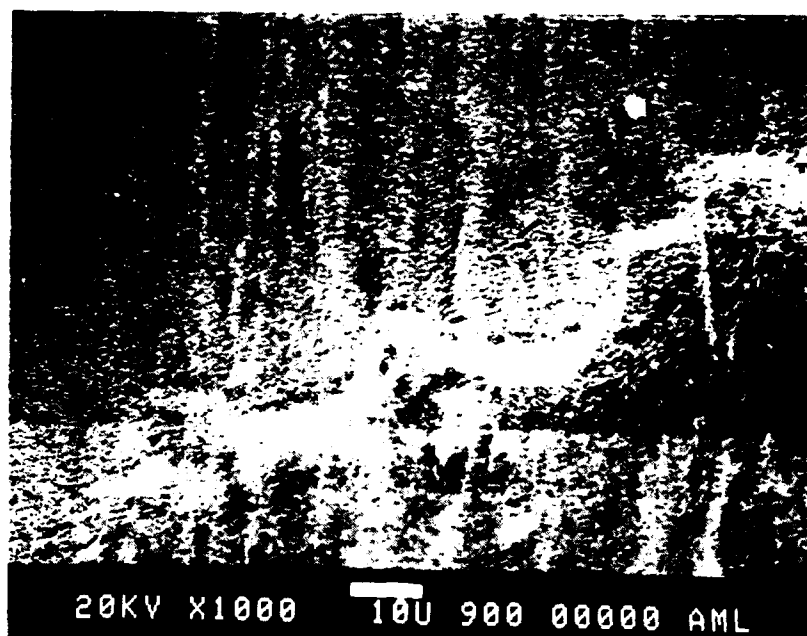
Figure 28. Cycom 3100/IM6 Composite, Interleaved With Teflon Treatment Two, Failed Through ENF Testing. Plastic Deformation Is Subtle.

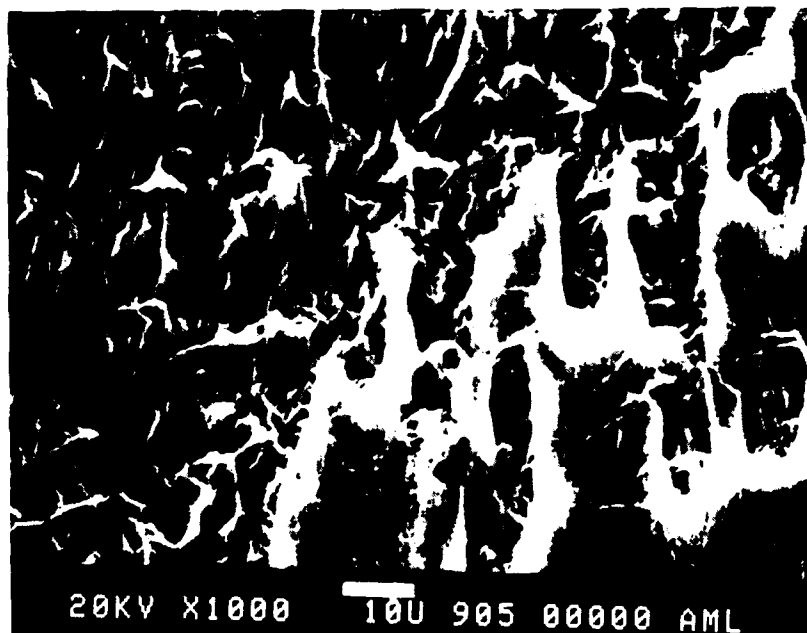
Figure 30. Cycom 3100/IM6 Composite, Interleaved With Teflon Treatment Three, Failed Through ENF Testing. Extensive Tearing and Stretching Of Teflon Film.
